ACE Project Report for Coconino National Forest

Title of Project: Western Gateway Trail System

Location: Western Gateway, Red Rock Ranger District

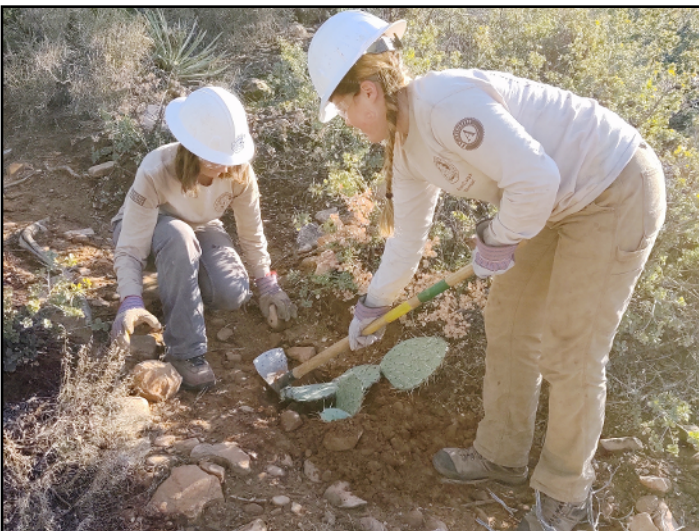
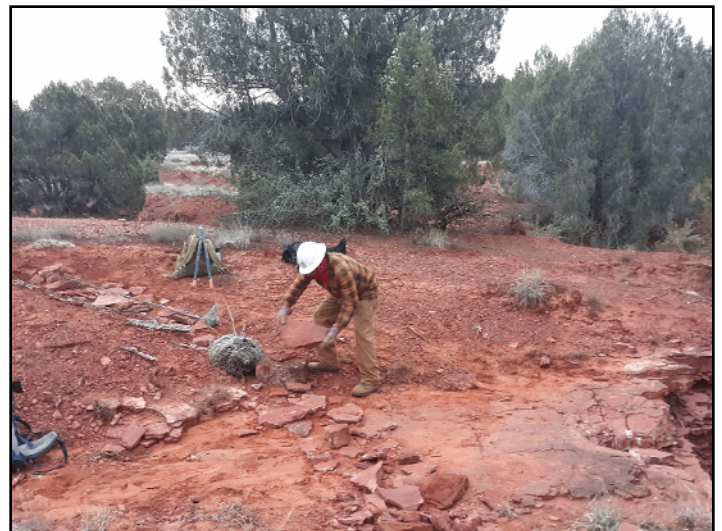
Social trails were closed on Saddle Up Trail, Stirrup Trail, Outer Limits Trail, Lasso-Axis Trail, and Girdner Trail. The method used to close trails involves decompacting the soil, visually eliminating the route and creating physical barriers with rocks, branches and vegetation. The above left photo depicts ACE corps members transplanting a Prickly Pear to help restore the social trail to its natural state. Above right shows a Crew member using rocks and vegetation to physically block access to a social trail.

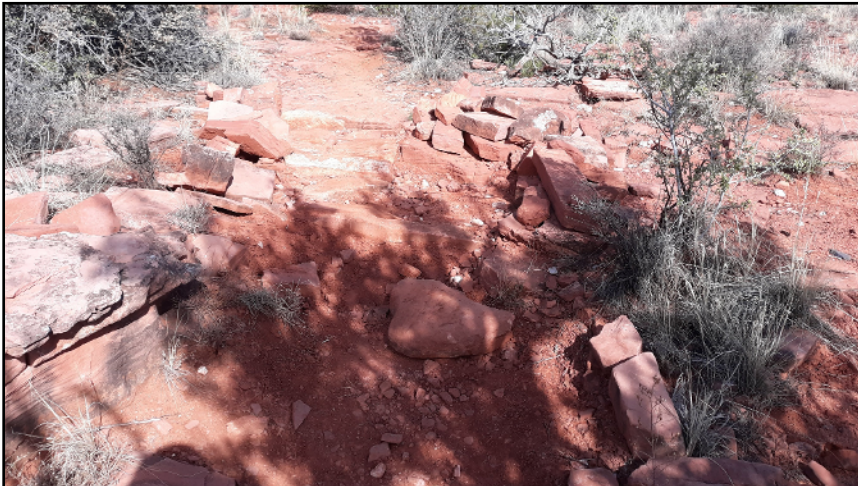
Before

Left: A section of rock armoring in need of repair, near the junction of Saddle Up Trail and Girdner Trail.

The rocks that had previously armored the tread had become loose and were impeding the flow and safety of the trail, as well as allowing tread soil to erode away.

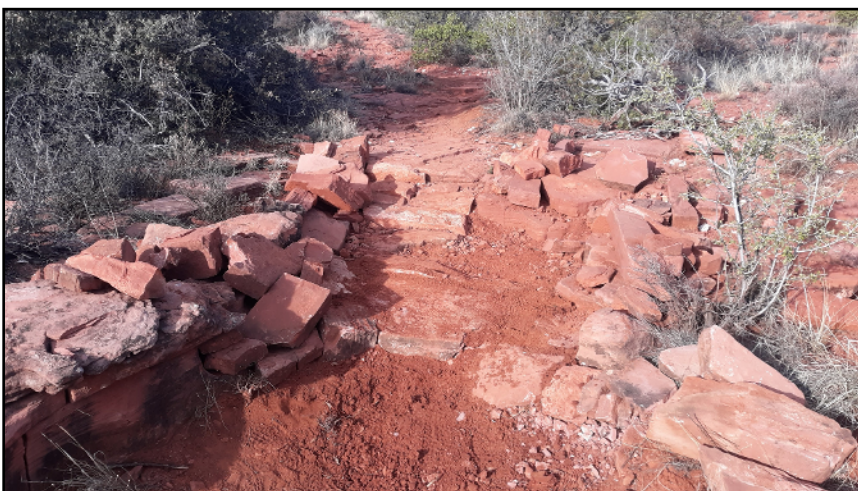
After

ACE replaced the rocks to withstand the impact of trail users by burying them sufficiently and filling gaps with crushed rocks.

This provided a hardened trail surface, resistant to heavy trail use and hydrological erosion.

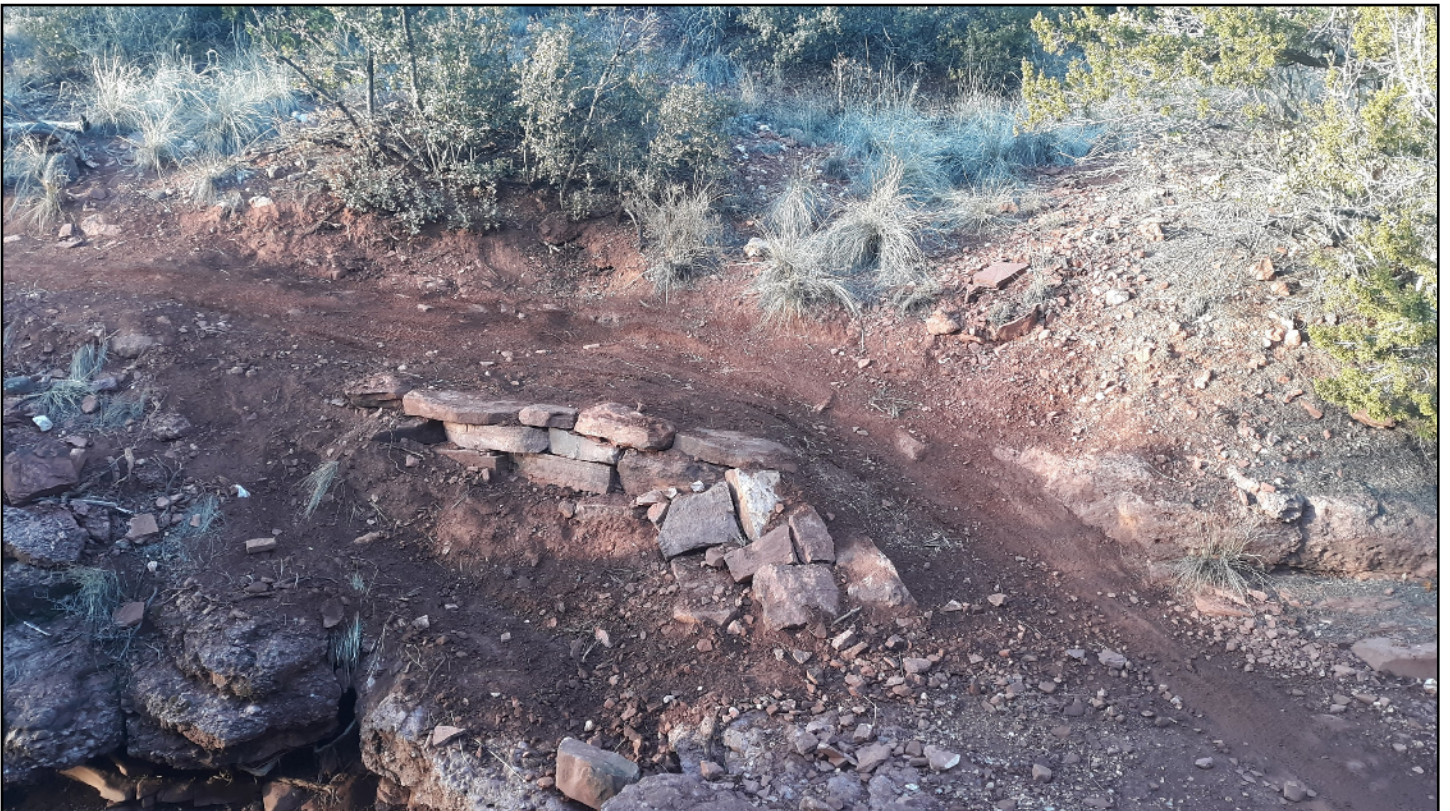
This second rock structure was built from scratch on the uphill side of a wash crossing. The steep slope and erosion-prone area called for reinforcement from a rock retaining wall. The USFS trail crew worked alongside ACE to build this structure, offering a valuable learning opportunity for the ACE crew and a chance for them to contribute ideas for a successful rock structure.

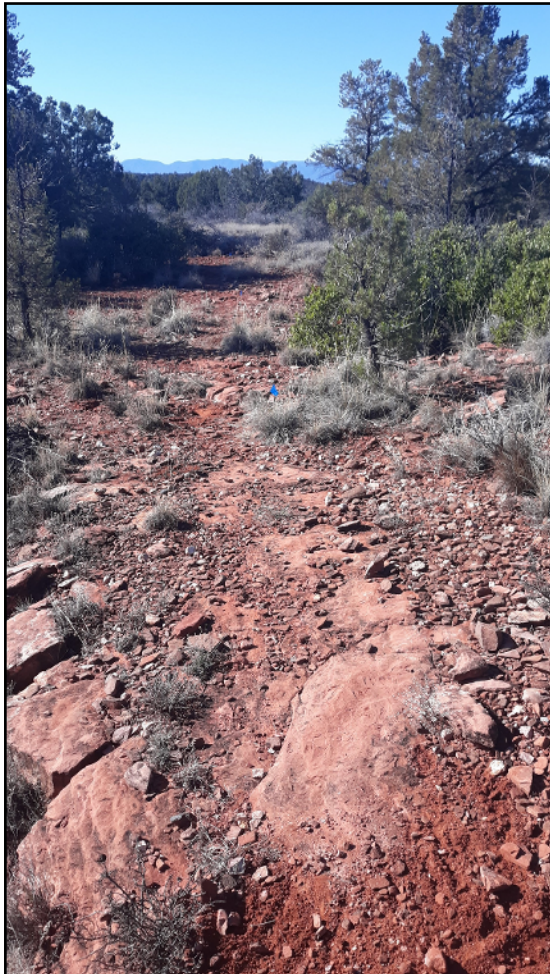
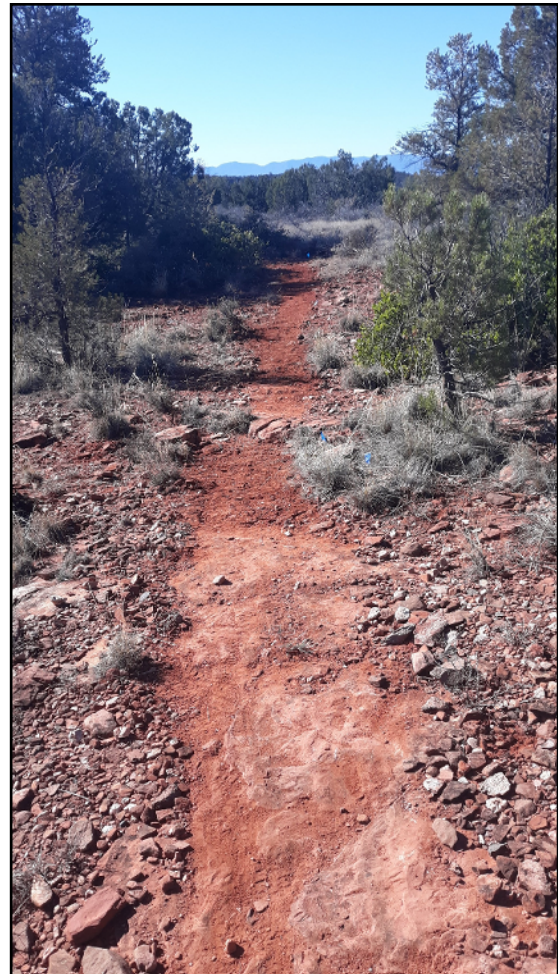
The ACE crews helped to complete a volunteer-built trail that now connects the Cockscomb Trail to Girdner Trail. The crews built new tread and cleared a 5ft wide by 10 ft high corridor of brush. This width demarcates the trail to users without allowing the trail tread to exceed a width of 24 inches, thereby reducing human impact. The 10ft height allows trail users, including equestrians to comfortably and safely pass on the trail.

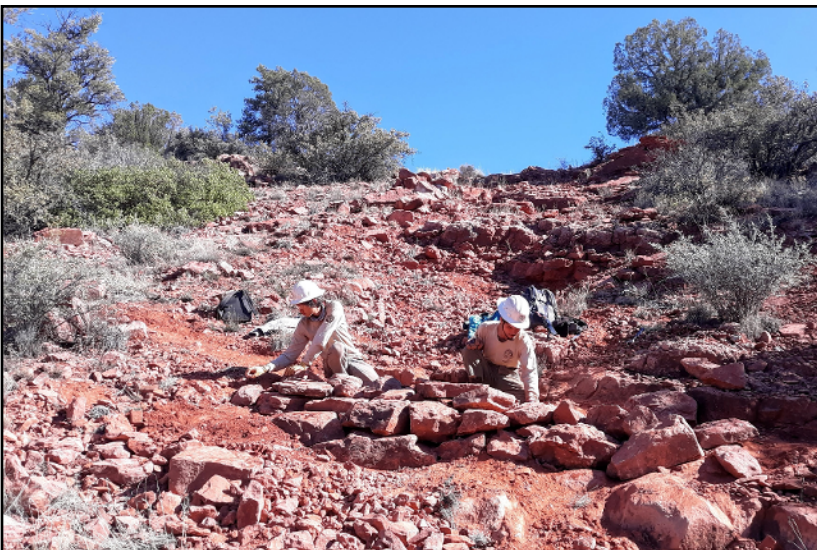
After initially building the trail, ACE and USFS trails crew observed the need for rock structures in vulnerable areas. Mainly at wash crossings and steeper sections of trail with erosive soil, rock reinforcements were needed. The photo to the left shows a junk wall to the downhill side of the trail on a steep side slope in a large area of water drainage. This structure helps to support the trail tread by preventing washout at the critical edge (downhill side).

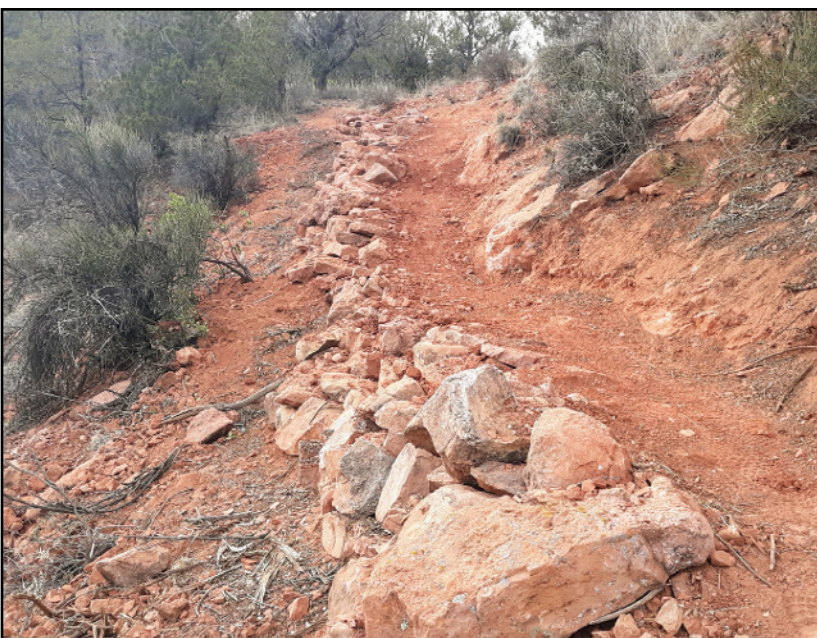
This photo depicts a rock retaining wall built to reinforce trail tread in an area where soil readily fell away from steep bedrock within the tread surface. The crews found this multi-tiered structure necessary to preserve soil. Notice that the crews used native materials to naturalize the downhill side after completion of the rock project.

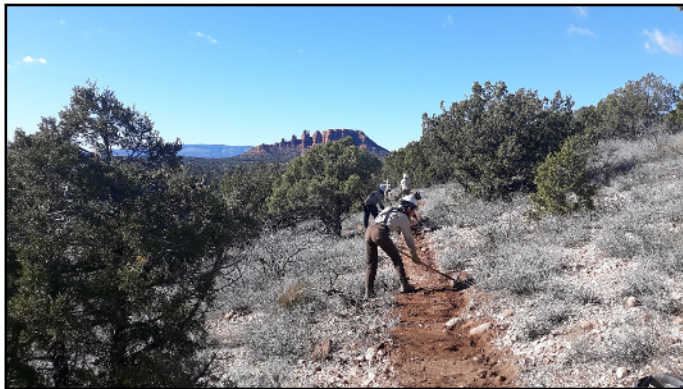
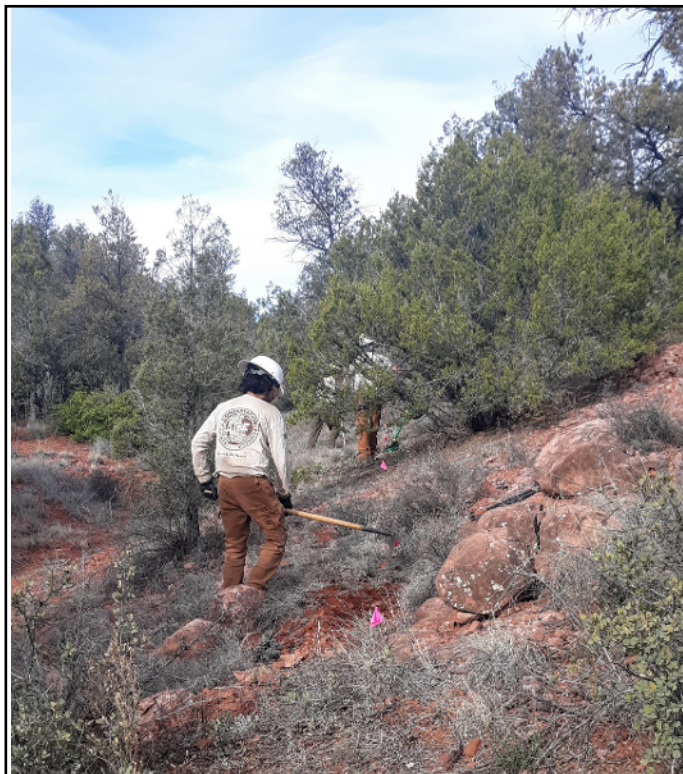
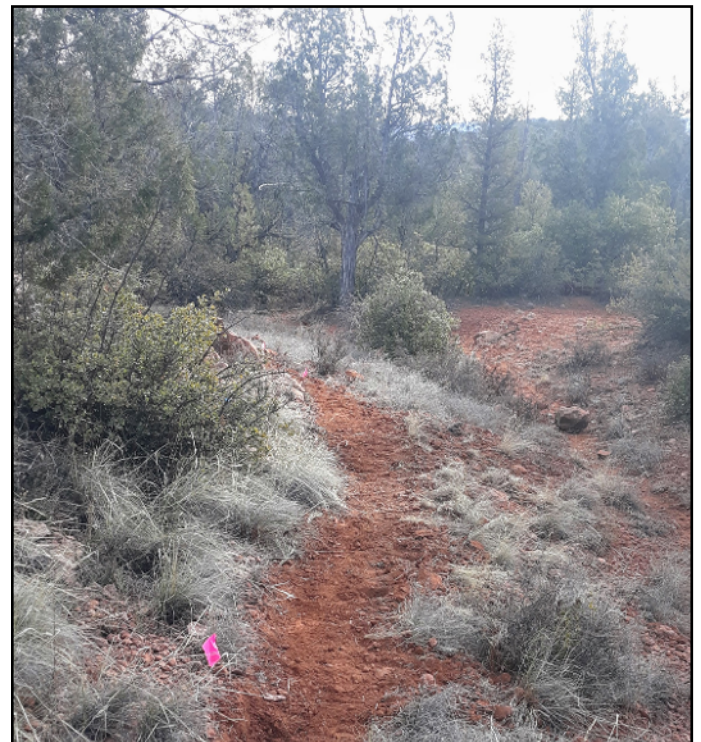
Each ACE crew worked from either end of the Bolo Trail to connect Last Frontier Trail to the newly built Axis Trail. The two crews completed this 0.5 mile long connector trail in a matter of days, adhering to the high standard of quality ACE is known for and the USFS requires. Short connecting trails like this one give variety to local trail users while establishing trails that are built in harmony with the land, with perpendicular wash crossings that allow water to exit the trail with minimal erosion.

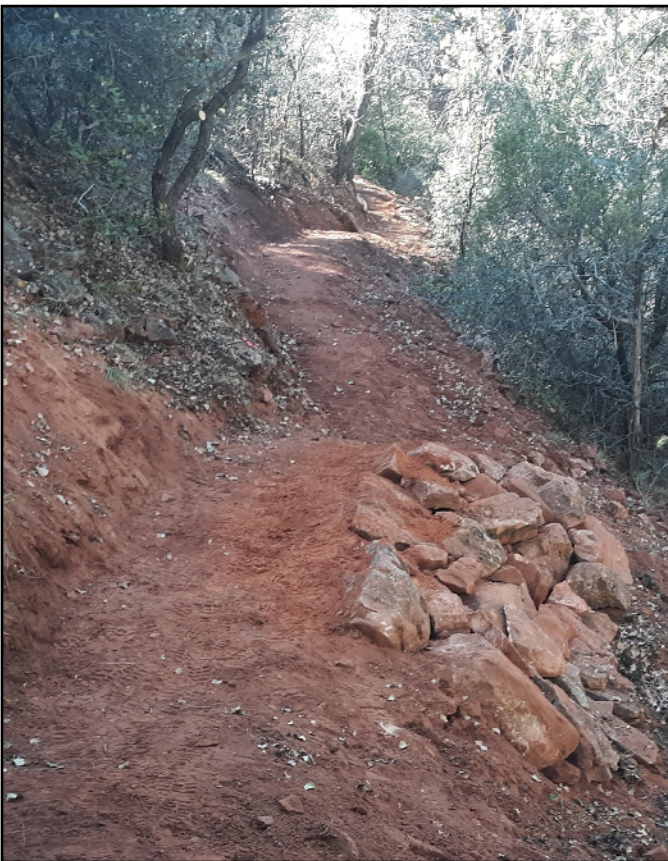
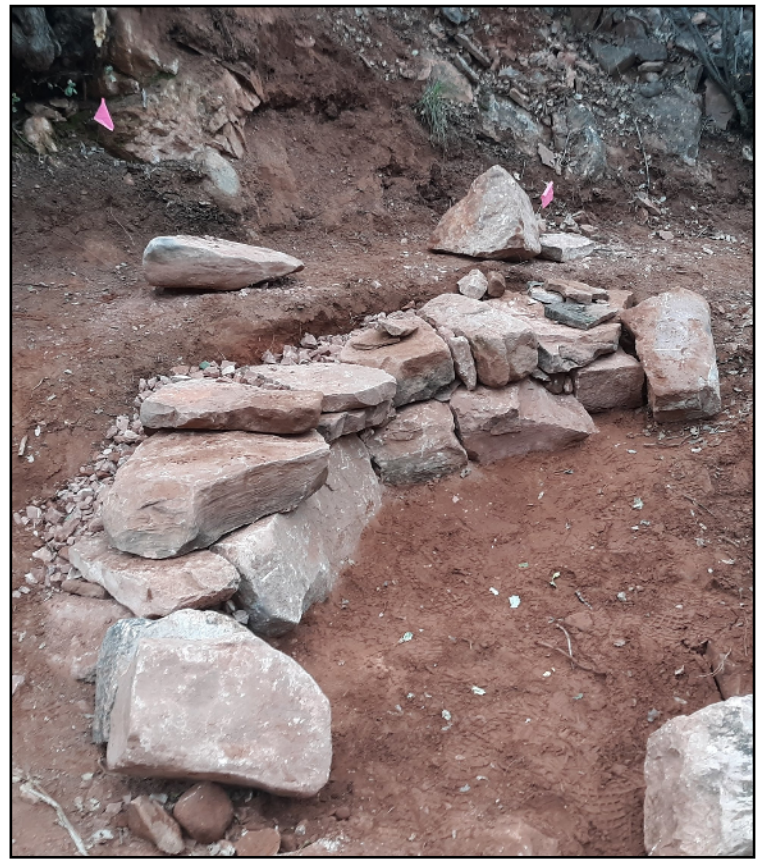
To finish out the 2020 season, ACE began work on Bottom Out Trail, rated double black diamond for mountain bikes. Building a trail that is both technically challenging yet safe and sustainable was an excellent learning experience for ACE corps members. The trail mostly follows a wash, with the tread sometimes situated on the bank of the streambed and at other times charging directly through the bottom of the stream channel. Commitment to establishing tread in steep and crumbling slopes as well as building several rock retaining walls made this eagerly anticipated trail a reality.

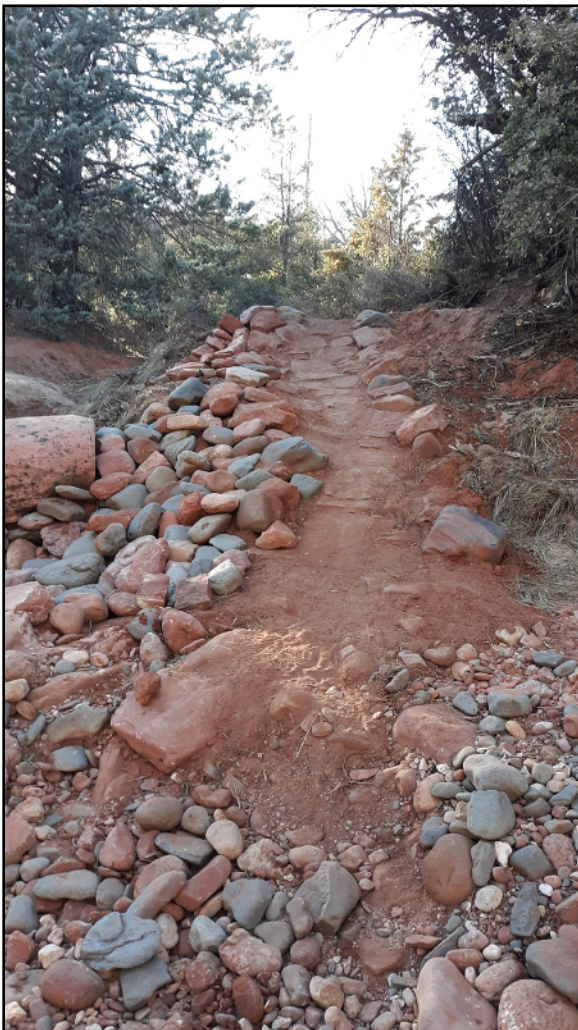
Tread Armoring

Left: A section of tread armor constructed on Axis Trail near its junction with Girdner Trail. This part of the trail climbs steeply out of the wash on a steep, sandy hill. Due to the erosive nature of the soil it was decided that armoring the tread with sturdy, interlocking rocks buried flush with the existing tread, would be the most sustainable solution. This provides a hardened tread surface and provides traction to trail users. The rocks stacked on either side of the tread function as additional erosion control and a barrier that keeps trail users within the corridor.

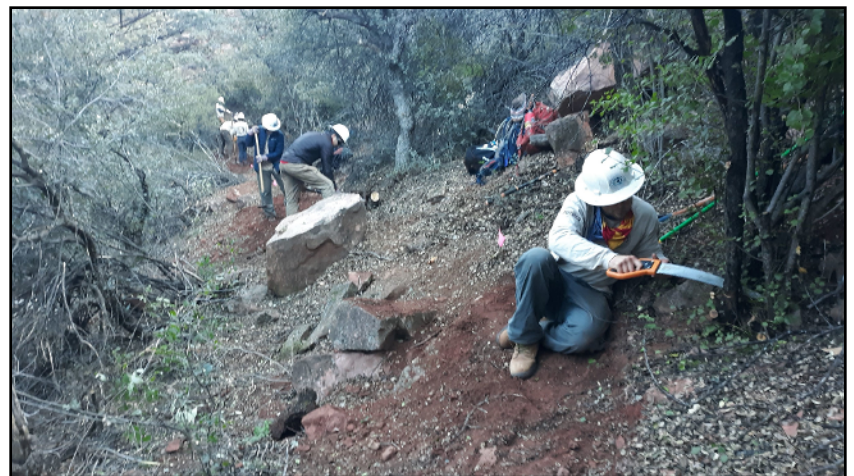
Brushing

Below: ACE crews brushed the trail corridor wherever necessary. This provides a clear path for trail users, enhancing safety and enjoyment of the trail. The below picture show the ACE crew clearing a corridor for new trail construction.

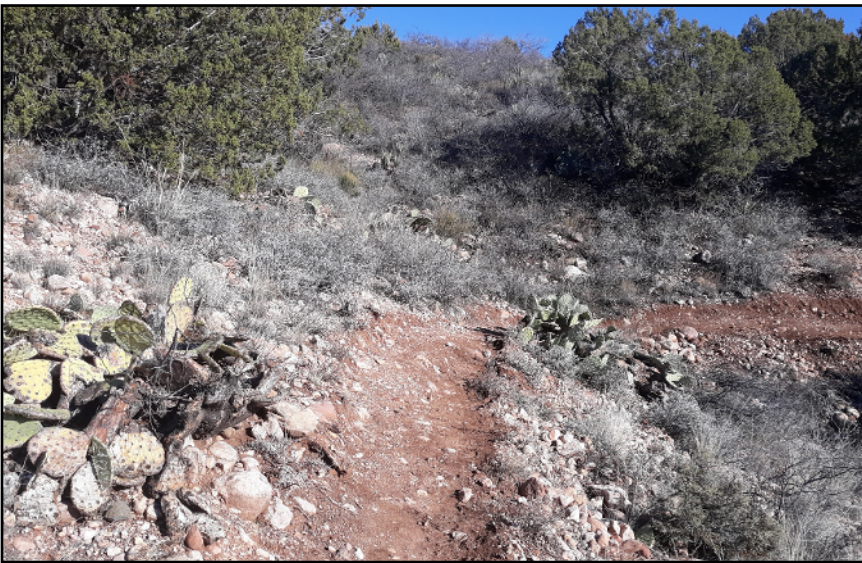
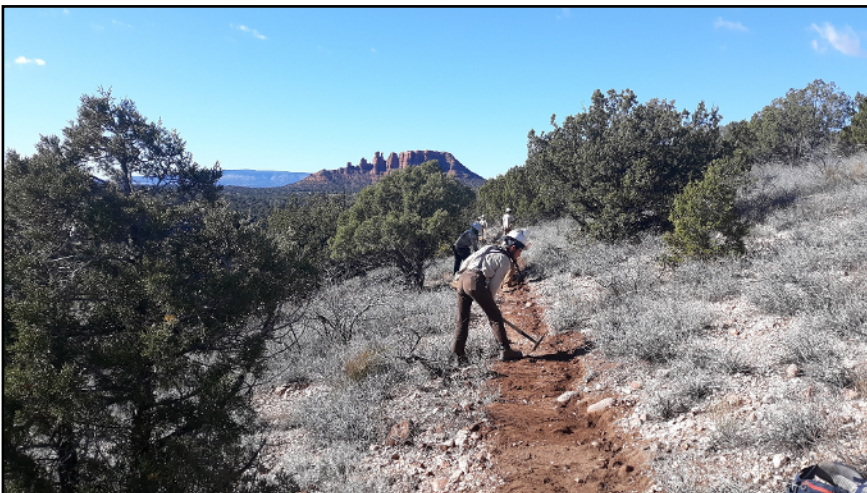
This section on Saddle Up Trail (top left) needed to be benched and widened. Over the past year since it was built, the hillside reclaimed the trail to the point that it had become too narrow and steep to be safe or comfortable for trail users. ACE worked on sections like this to ensure all of the trail tread was 18-24 inches wide and flat enough to keep trail users off of the fragile critical edge, yet to allow for sheet flow of water. The crew reshaped the backslope the trail to a uniform 45 degree angle in order to allow water to slowly make its way onto the trail, thus preventing channelization of water or sloughing of material onto the trail tread. The tread itself is slightly outsloped to the critical edge side (downhill) to allow water to make its way off the trail tread.
